INSTRUCTIONS FOR CONTINUED AIRWORTHINESS

ICA MANUAL No. VMM-206B3-301

Tail Rotor Blade Assembly 2062200-101/-301
Eligible for Installation on Model 206A/B

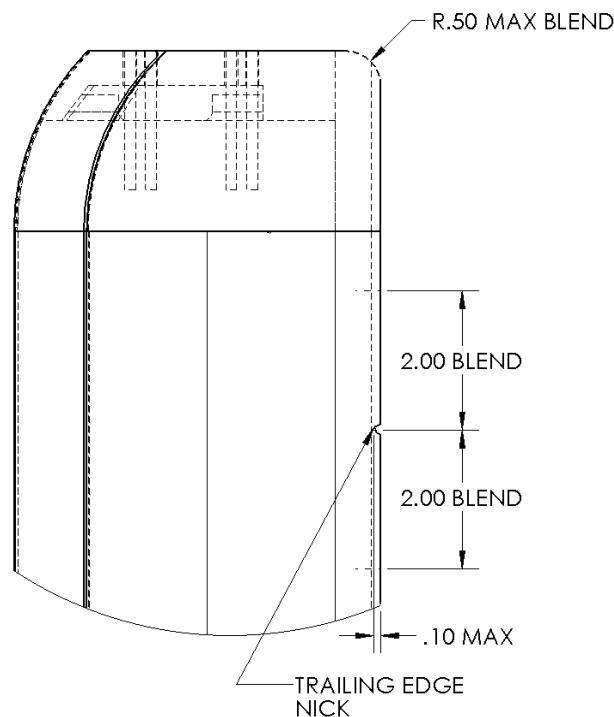
Figure 5.1
Trailing Edge and Tip Damage Limits

- b. Voids not exceeding 1.00 inch diameter are acceptable at any location except for edge voids at the tip of the blade.
- c. Edge voids between the skin and tip closeout are not permitted.
- d. If voids are detected, remove paint in the damaged area to check for broken fibers. Remove paint and primer only. Do not sand into skin plies.
- e. Broken fibers are not permitted. If broken fibers are detected, send blade to an authorized FAA repair station for evaluation, and if possible, repair. Contact VHA for repair station recommendations
- f. Scratches, nicks, or fiber damage in the extreme trailing edge 0.10 deep or less may be blended out over a distance of at least 2.0 inches each side of the damage. See Figure 5.1 below.
- g. Damage at the tip trailing edge may be removed by blending up to a 0.50 inch radius at the tip. See Figure 5.1 below.

- a. Voids are not allowed within 0.50 inch of the trailing edge.

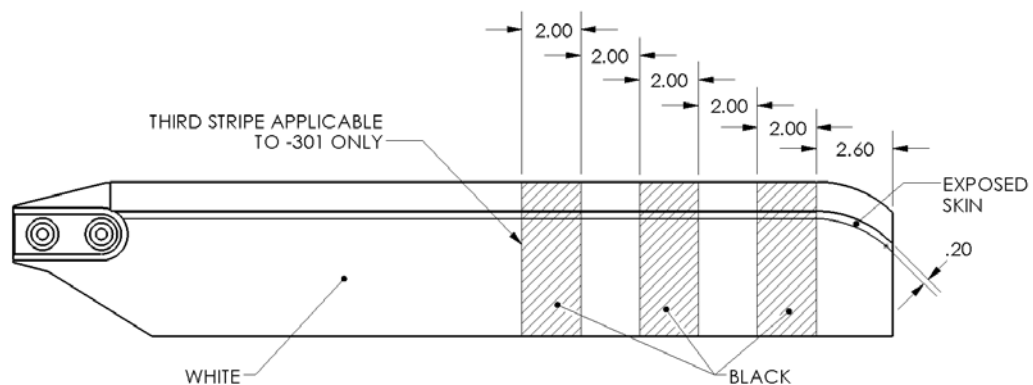
Figure 5.2
 Paint Color Scheme

VHA finishes the tail rotor blade using an epoxy surfacing film co-cured with the skin, epoxy paint primer, and polyurethane top coat. Basic blade color is white with 2.0 inch high visibility black stripes as shown in Figure 5.2.

- b. Paint wear due to erosion at the tip may expose the carbon/epoxy skin to ultra violet radiation and moisture absorption.
- c. Exposed skin not exceeding 0.20 inch aft of abrasion strip trailing edge must be protected by at least one coat of epoxy primer within 25 flight hours of exposure. See Figure 5.2.

- d. Exposed skin exceeding 0.20 inch aft of abrasion strip trailing edge must be protected by at least one coat of epoxy primer within 10 flight hours of exposure. See Figure 5.2.

- g. Paint is DuPont Imron Elite SS Single Stage Color. Any aerospace quality polyurethane paint may be substituted. Use a compatible epoxy primer.
- h. White paint is DuPont color 786255.

- i. Black paint is DuPont color 99.

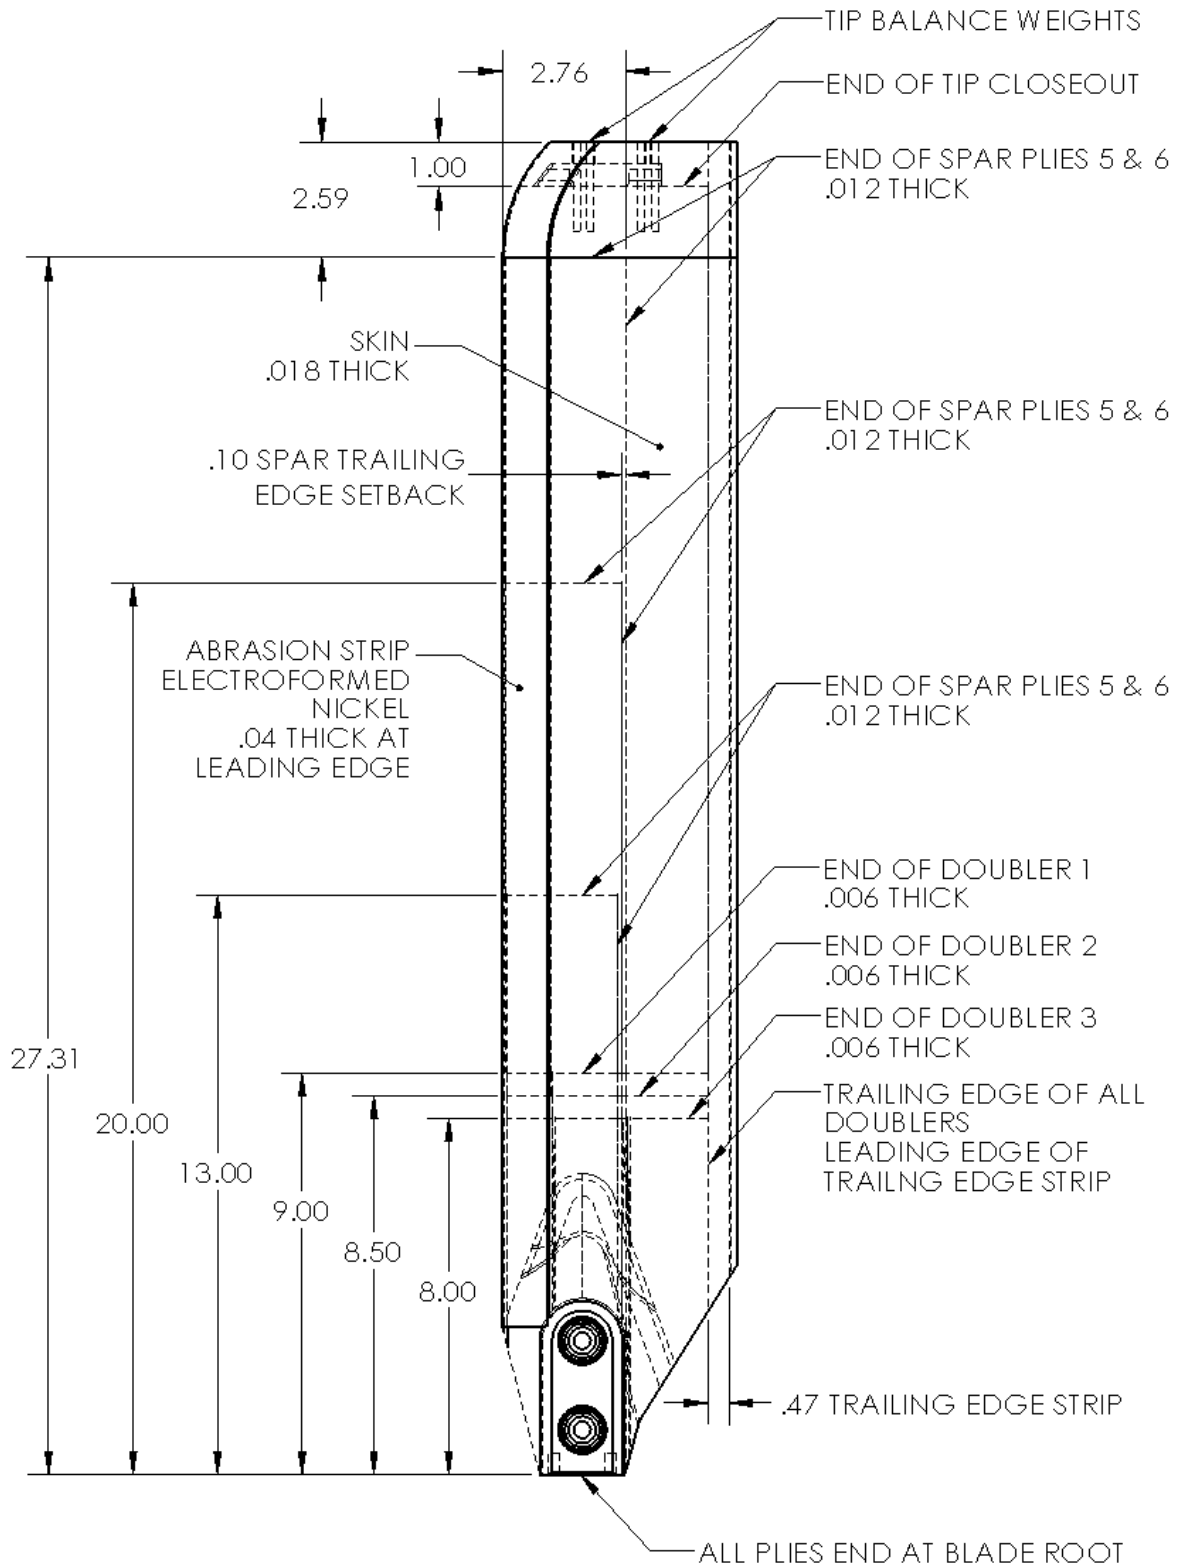
Figure 5.3
Tail Rotor Blade

Impact damage may progress from little evidence of external damage to puncture with surrounding voids depending on impact force. In all cases of suspected skin damage, a tap test is required to determine extent of the damage. Figure 5.3 shows the blade internal components including locations of ply drop-offs. Take note of the various thicknesses and ply drop-off locations. A tonal change may occur at these drop-offs when tapping across them depending on tapping force. If suspected damage is on or near a ply drop-off, it may be required to tap an undamaged blade in the same area to help distinguish a tonal change from a void.

- d. Tap test an area 1.0 inch either side of the dent for voids. See Figure 5.3 for locations of ply drop-offs. A tonal change may occur at these drop-offs when tapping across them depending on tapping force. If a dent is on or near a ply drop-off, it may be required to tap an undamaged blade in the same area to help distinguish a tonal change from a void.

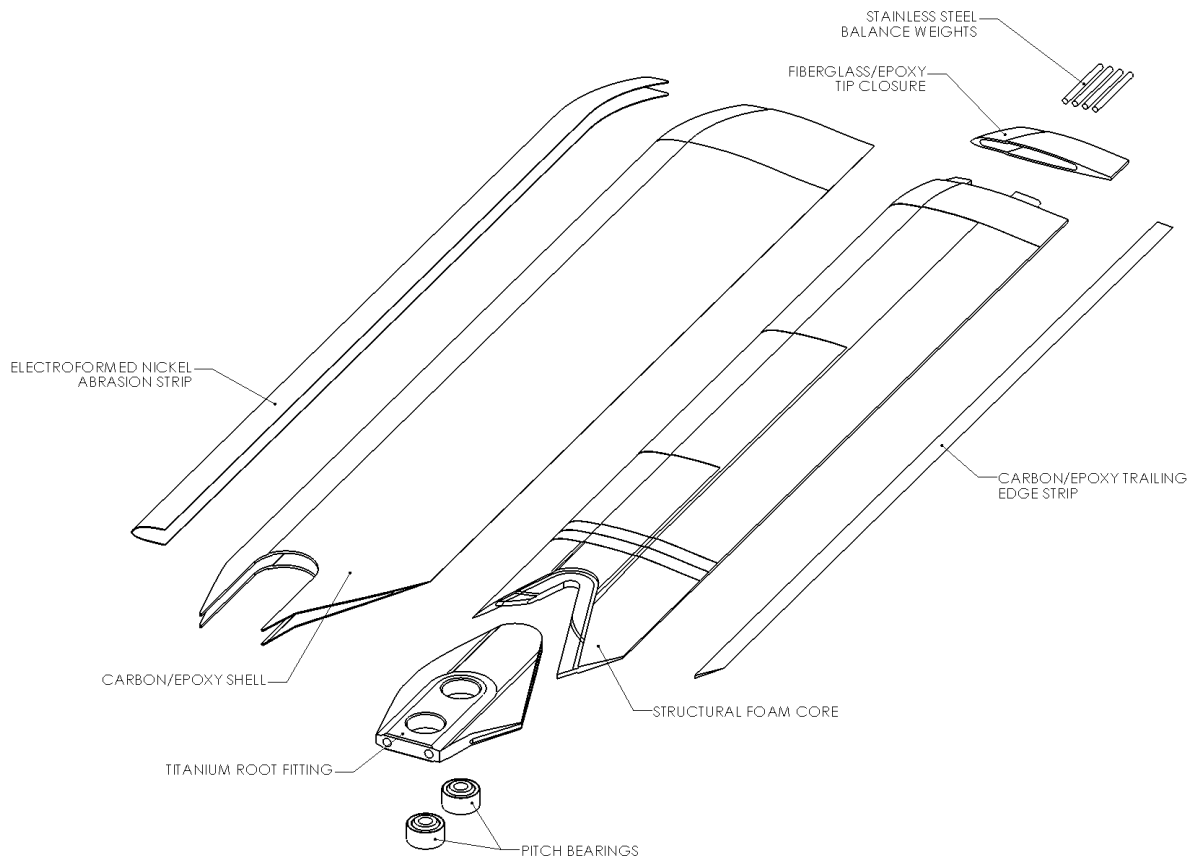
Figure 62.1.1
Tail Rotor Blade Description

The 2062200-101/-301 tail rotor blade is a composite and metallic structure incorporating the NASA developed RC(4)-10(10% thick) rotor blade airfoil. This is a highly efficient laminar flow airfoil developed to have near zero pitching moments across a broad range of airspeeds. The blade radius is approximately .10 inches shorter than the existing production tail rotor blade. The blade chord length is the same as the existing blade at 5.25 inches. The tip of the blade is rounded to reduce noise and tip drag. The root fitting is machined from titanium alloy plate. The pitch bearings incorporate both a stainless steel race and sphere, and a Teflon liner. The sphere is chrome plated. The basic blade section is fabricated using unidirectional carbon/epoxy tape with a rigid cell structural foam core. Span balance is accomplished using threaded stainless steel screws in a fiberglass/epoxy high pressure laminate tip cap. An electroformed nickel abrasion strip is added for erosion protection.

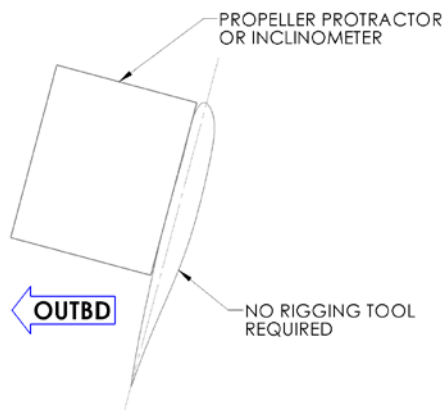
- a. 17.0° to 17.5° for helicopters with long tail rotor blades. S/N 4 through 2211 modified per 62.3.2, and S/N 2212 through 4004.
- b. 22.75° to 23.25° for helicopters S/N 4005 and subsequent.

62.3.4 Use protractor as shown in the figure below.
