## **INSTRUCTIONS FOR CONTINUED AIRWORTHINESS**

### **ICA MANUAL No. VMM-206L4-309**

**Tail Rotor Blade Assembly 2062200-101/-301**  
**Eligible for Installation on Model 206L4**

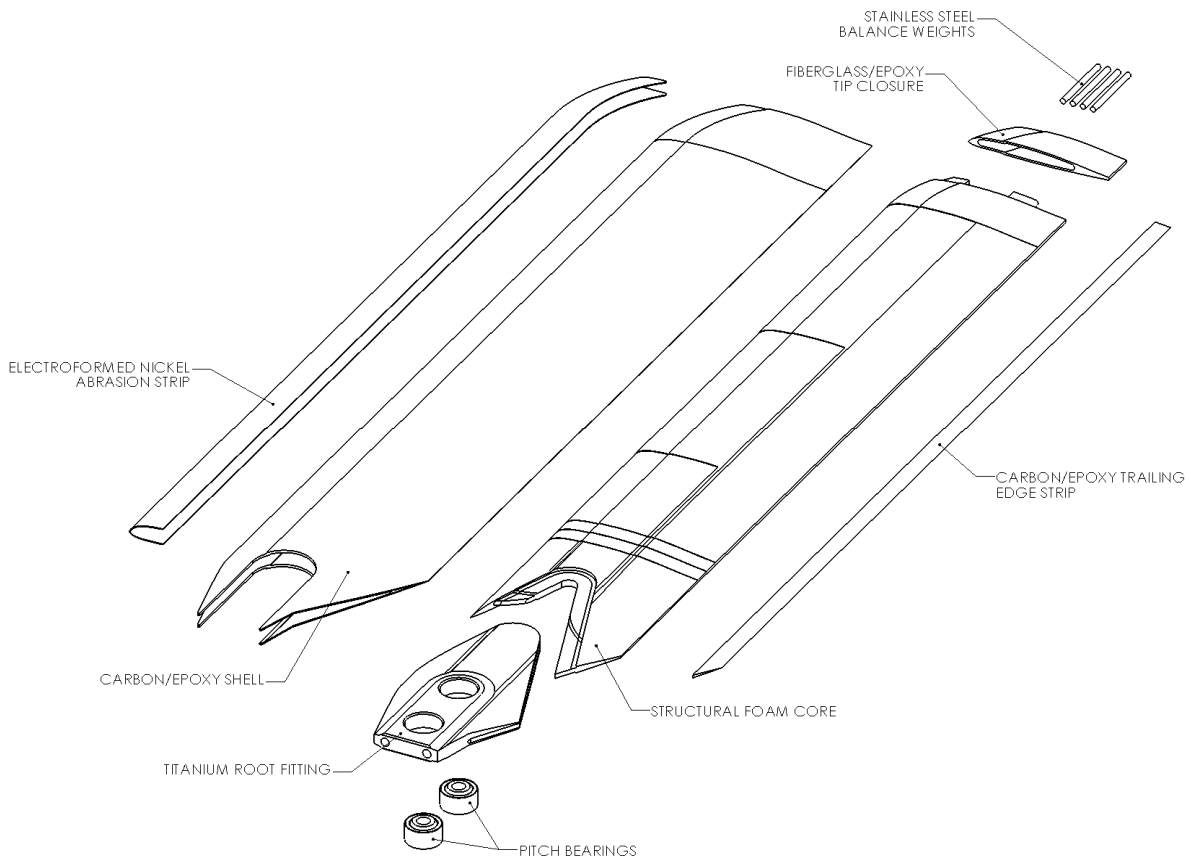
Figure 62.1.1  
Tail Rotor Blade Description

The 2062200-101/-301 tail rotor blade is a composite and metallic structure incorporating the NASA developed RC(4)-10(10% thick) rotor blade airfoil. This is a highly efficient laminar flow airfoil developed to have near zero pitching moments across a broad range of airspeeds. The blade radius is approximately .10 inches shorter than the existing production tail rotor blade. The blade chord length is the same as the existing blade at 5.25 inches. The tip of the blade is rounded to reduce noise and tip drag. The root fitting is machined from titanium alloy plate. The pitch bearings incorporate both a stainless steel race and sphere, and a Teflon liner. The sphere is chrome plated. The basic blade section is fabricated using unidirectional carbon/epoxy tape with a rigid cell structural foam core. Span balance is accomplished using threaded stainless steel screws in a fiberglass/epoxy high pressure laminate tip cap. An electroformed nickel abrasion strip is added for erosion protection.

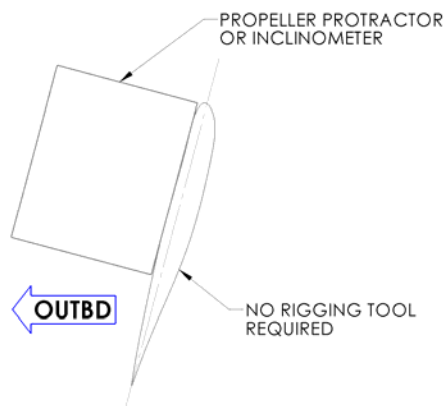
62.3.2 Blade angles are reduced by  $0.5^{\circ}$ . Subtract  $0.5^{\circ}$  degrees from the high and low blade angles in the FAA accepted maintenance manual. For example if the FAA accepted maintenance manual calls for  $23.25^{\circ}$  to  $23.75^{\circ}$ , rig the 2062200-101/-301 blades to  $22.75^{\circ}$  to  $23.25^{\circ}$ . Except for the reduced angle, rig the blades per the FAA accepted maintenance manual and the figure below.

62.3.1 Counterweight washers may not be required. Begin rigging by removing all washers and the bolt and nut. If counterweights are required, use only one half of the maximum counterweight washers called out in the FAA accepted maintenance manual.
