Van Horn Aviation, L.L.C.
*1000 E. Vista Del Cerro Dr.
Tempe, Arizona 85281*

INSTRUCTIONS FOR CONTINUED AIRWORTHINESS

ICA MANUAL No. VMM-OH58-315

**Tail Rotor Blade Assembly 2062200-101
Eligible for Installation on San Joaquin Helicopters
Model OH-58A+ and OH-58C Helicopters**

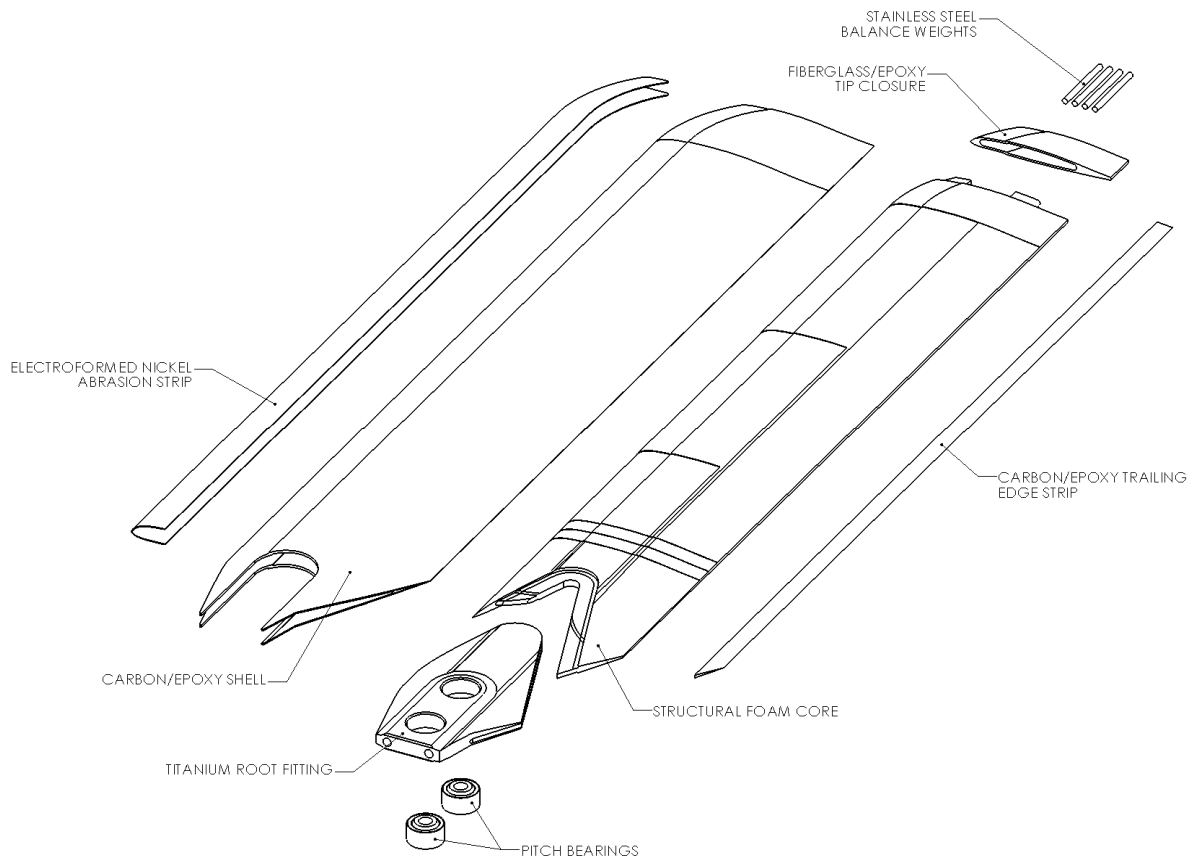
Figure 62.1.1
Tail Rotor Blade Description

The 2062200-101 tail rotor blade is a composite and metallic structure incorporating the NASA developed RC(4)-10(10% thick) rotor blade airfoil. This is a highly efficient laminar flow airfoil developed to have near zero pitching moments across a broad range of airspeeds. The blade radius is approximately .10 inches shorter than the existing production tail rotor blade. The blade chord length is the same as the existing blade at 5.25 inches. The tip of the blade is rounded to reduce noise and tip drag. The root fitting is machined from titanium alloy plate. The pitch bearings incorporate both a stainless steel race and sphere, and a Teflon liner. The sphere is chrome plated. The basic blade section is fabricated using unidirectional carbon/epoxy tape with a rigid cell structural foam core. Span balance is accomplished using threaded stainless steel screws in a fiberglass/epoxy high pressure laminate tip cap. An electroformed nickel abrasion strip is added for erosion protection.
