**Van Horn Aviation, L.L.C.**  
*1510 W. Drake Drive*  
*Tempe, Arizona 85283*

## **INSTRUCTIONS FOR CONTINUED AIRWORTHINESS**

### **ICA MANUAL No. VMM-206L3-307**

**Tail Rotor Blade Assembly 2062200-101/-301**  
**Eligible for Installation on Model 206L3**

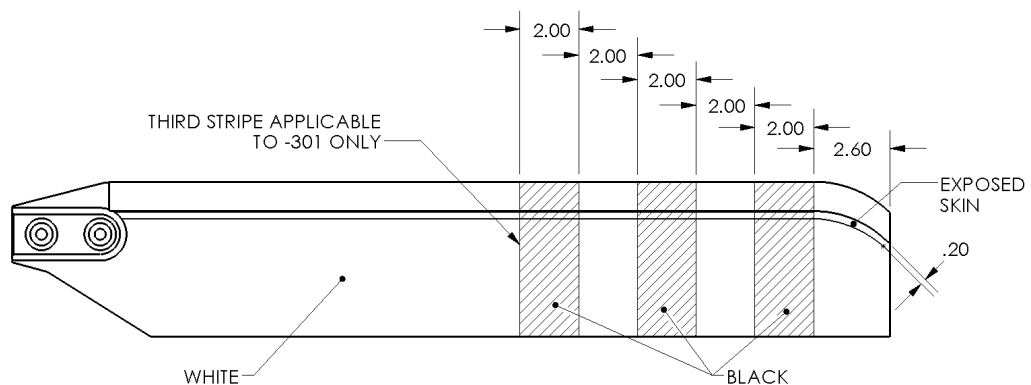
VHA finishes the tail rotor blade using an epoxy surfacing film co-cured with the skin, epoxy paint primer, and polyurethane top coat. Basic blade color is white with 2.0 inch high visibility black stripes as shown in Figure 5.2.

Figure 5.2  
 Paint Color Scheme

- b. Paint wear due to erosion at the tip may expose the carbon/epoxy skin to ultra violet radiation and moisture absorption.
- c. Exposed skin not exceeding 0.20 inch aft of abrasion strip trailing edge must be protected by at least one coat of epoxy primer within 25 flight hours of exposure. See Figure 5.2.

- d. Exposed skin exceeding 0.20 inch aft of abrasion strip trailing edge must be protected by at least one coat of epoxy primer within 10 flight hours of exposure. See Figure 5.2.

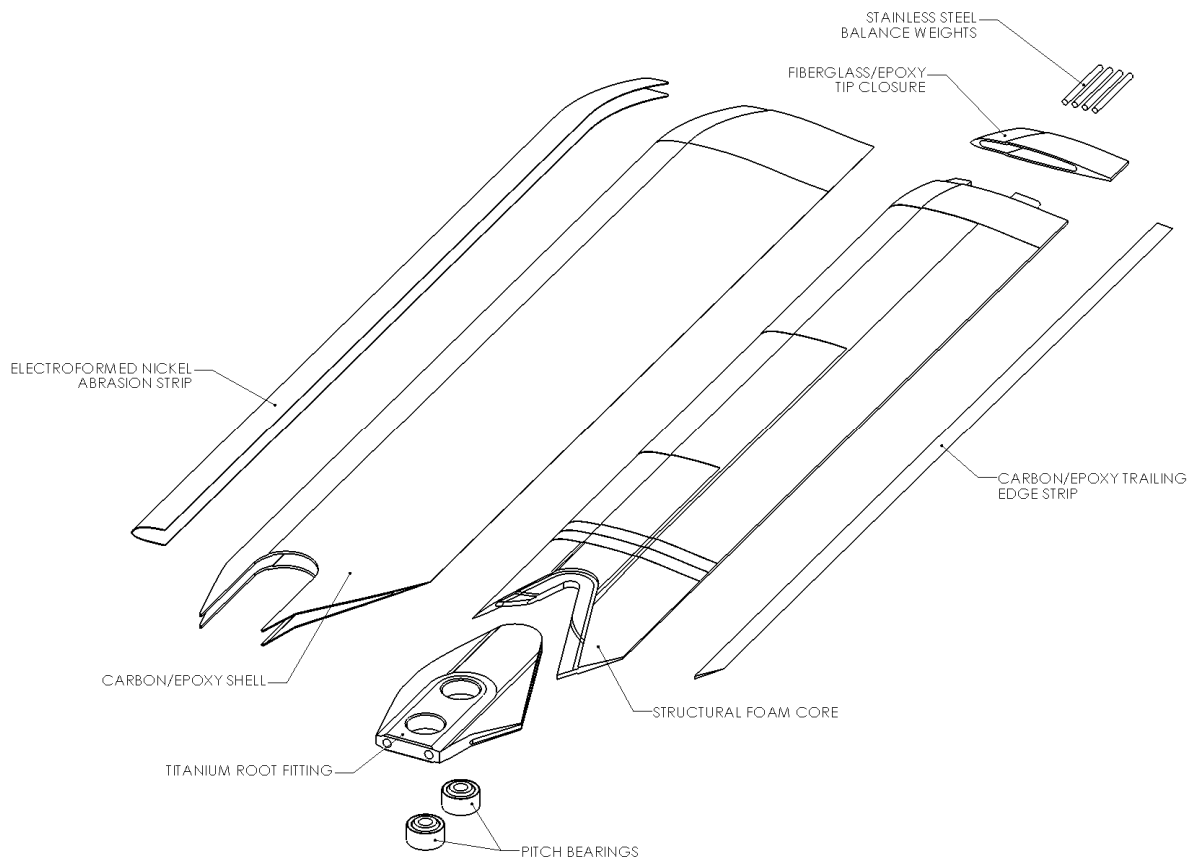
The 2062200-101/-301 tail rotor blade is a composite and metallic structure incorporating the NASA developed RC(4)-10(10% thick) rotor blade airfoil. This is a highly efficient laminar flow airfoil developed to have near zero pitching moments across a broad range of airspeeds. The blade radius is approximately .10 inches shorter than the existing production tail rotor blade. The blade chord length is the same as the existing blade at 5.25 inches. The tip of the blade is rounded to reduce noise and tip drag. The root fitting is machined from titanium alloy plate. The pitch bearings incorporate both a stainless steel race and sphere, and a Teflon liner. The sphere is chrome plated. The basic blade section is fabricated using unidirectional carbon/epoxy tape with a rigid cell structural foam core. Span balance is accomplished using threaded stainless steel screws in a fiberglass/epoxy high pressure laminate tip cap. An electroformed nickel abrasion strip is added for erosion protection.

Figure 62.1.1  
Tail Rotor Blade Description
