INSTRUCTIONS FOR CONTINUED AIRWORTHINESS

ICA MANUAL No. VMM-UH1B-316

Tail Rotor Blade Assembly 2042200-101
Eligible for Installation on San Joaquin Helicopters UH-1B Helicopters
Reference Van Horn Aviation, L.L.C. STC SR02051LA

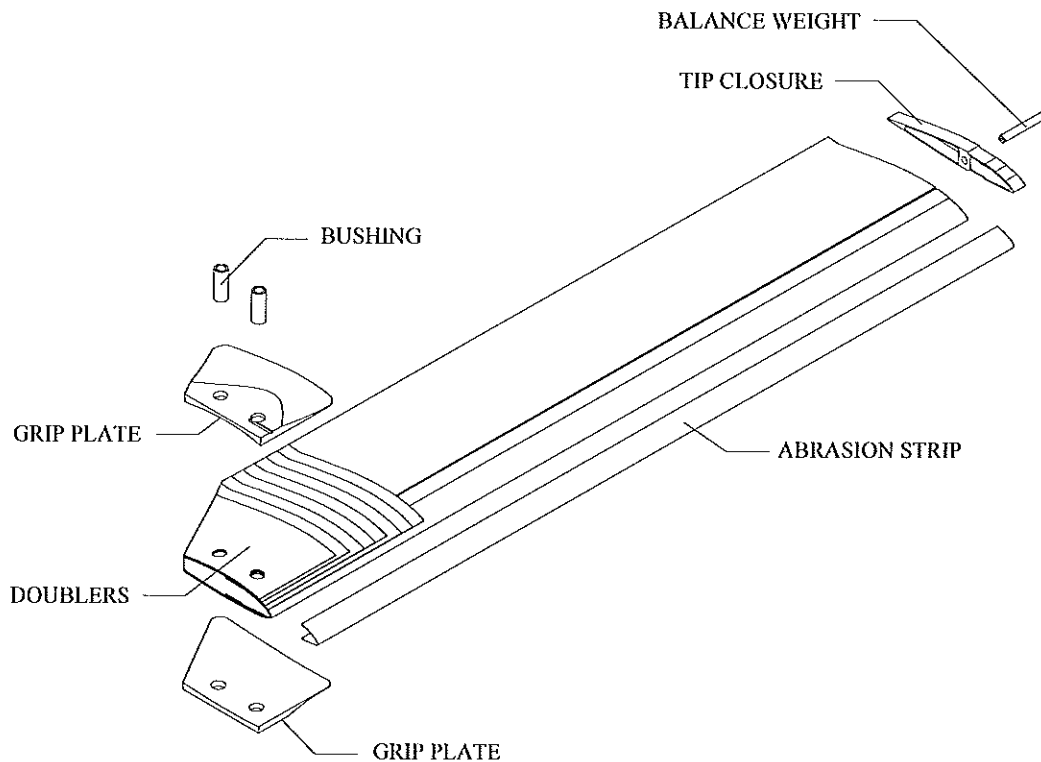
Figure 60.2.1
Tail Rotor Blade Description

The 2042200-101 tail rotor blade is an all composite blade employing an advanced highly efficient airfoil. The blade length is the same as the existing production blade, but the width of the blade is .80 inches longer. Erosion protection is provided by a full span stainless steel abrasion strip adhesively bonded to the leading edge. Stainless steel bushings are pressed into the inboard end to react the attachment bolt loads. The blade is constructed primarily of carbon/epoxy unidirectional tape. The grip plates, tip closure and root closure are fabricated from fiberglass/epoxy fabric. The blade is statically balanced at the factory using a brass balance weight threaded into the tip closure. The interior of the blade is filled with closed cell rigid foam.
