INSTRUCTIONS FOR CONTINUED AIRWORTHINESS

ICA MANUAL No. VMM-UH1B-317

Tail Rotor Blade Assembly 2042200-101
Eligible for Installation on International Helicopters UH-1B Helicopters
Reference Van Horn Aviation, L.L.C. STC SR02051LA

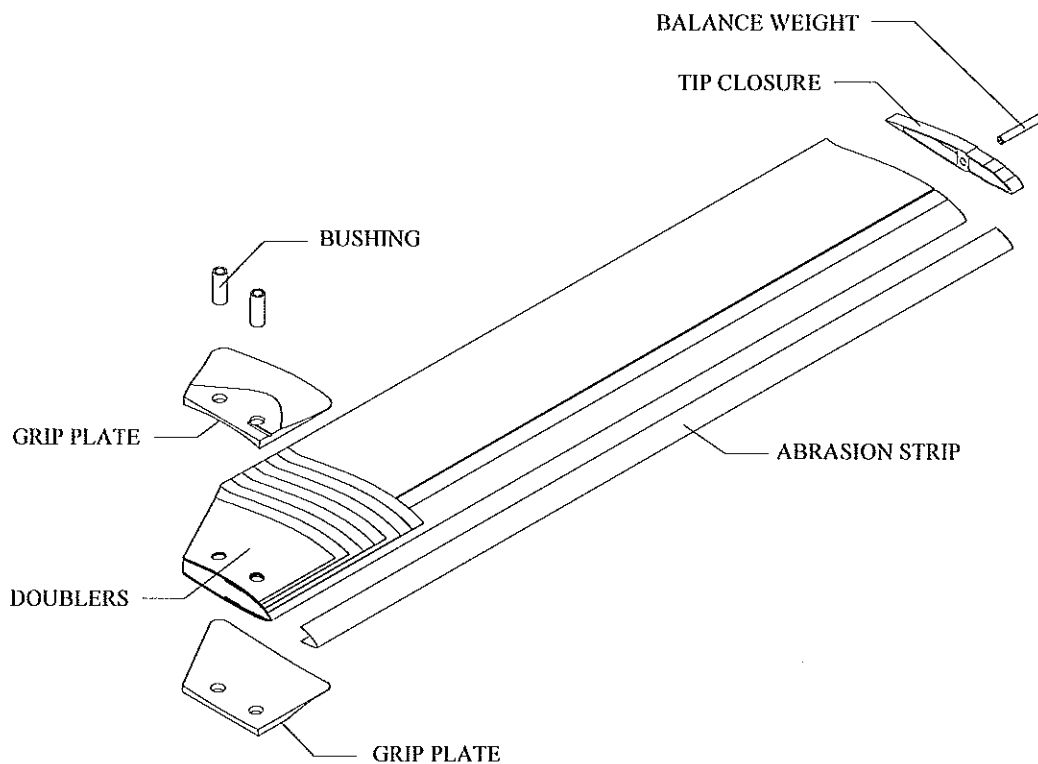
Figure 60.2.1
Tail Rotor Blade Description

The 2042200-101 tail rotor blade is an all composite blade employing an advanced highly efficient airfoil. The blade length is the same as the existing production blade, but the width of the blade is .80 inches longer. Erosion protection is provided by a full span stainless steel abrasion strip adhesively bonded to the leading edge. Stainless steel bushings are pressed into the inboard end to react the attachment bolt loads. The blade is constructed primarily of carbon/epoxy unidirectional tape. The grip plates, tip closure and root closure are fabricated from fiberglass/epoxy fabric. The blade is statically balanced at the factory using a brass balance weight threaded into the tip closure. The interior of the blade is filled with closed cell rigid foam.
